Project Title: "Strengthening of Existing Bridges Using Epoxy Injection."

Project No: E-20-625

Sponsor: Georgia Department of Transportation

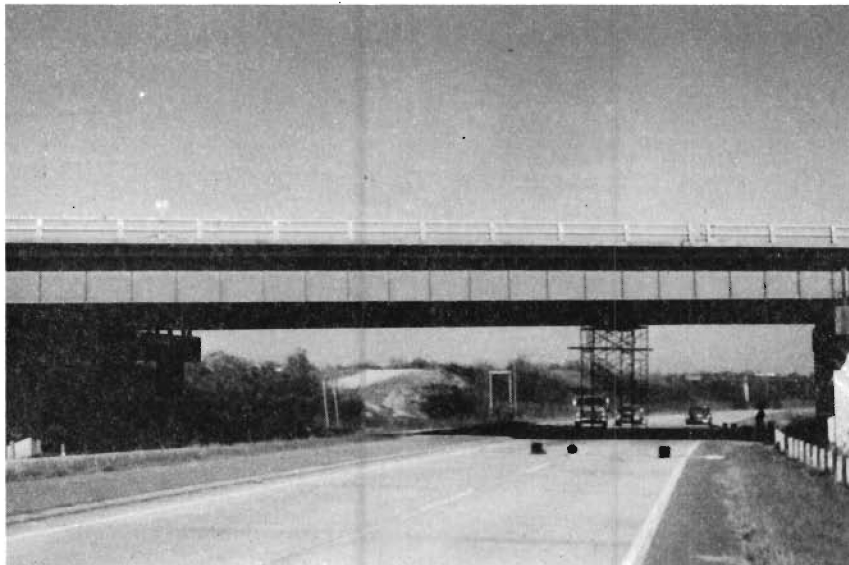
Figure 1: Camp Creek Parkway Bridge

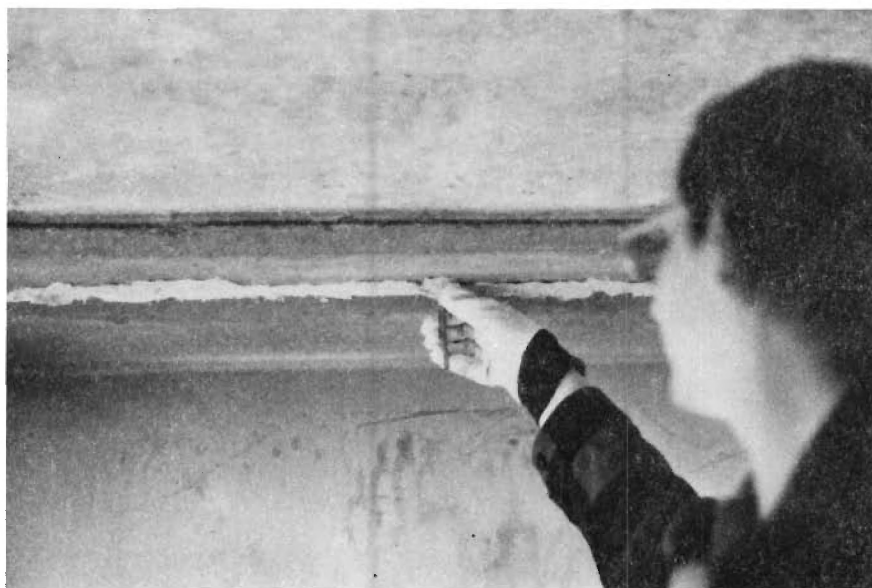
Figure 6: Sealer application around ports of Girder 1.

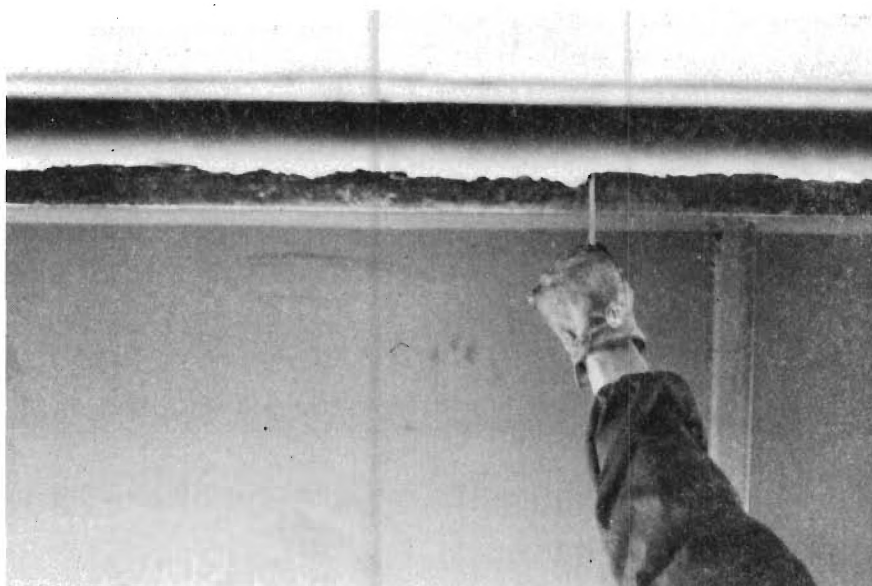
Figure 7: Insertion of copper tube ports into Girder 3.

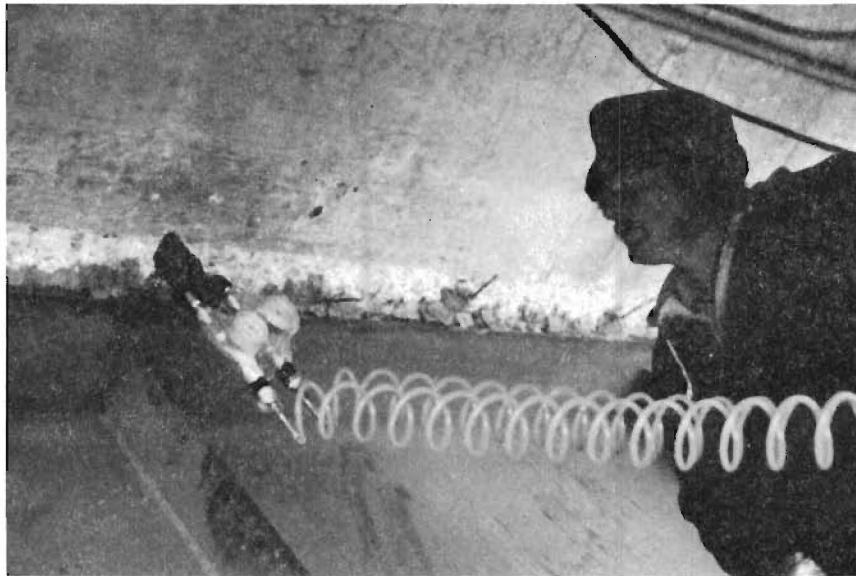
Figure 14: Automatic mixing at nozzle. Note separate hoses for epoxy components.

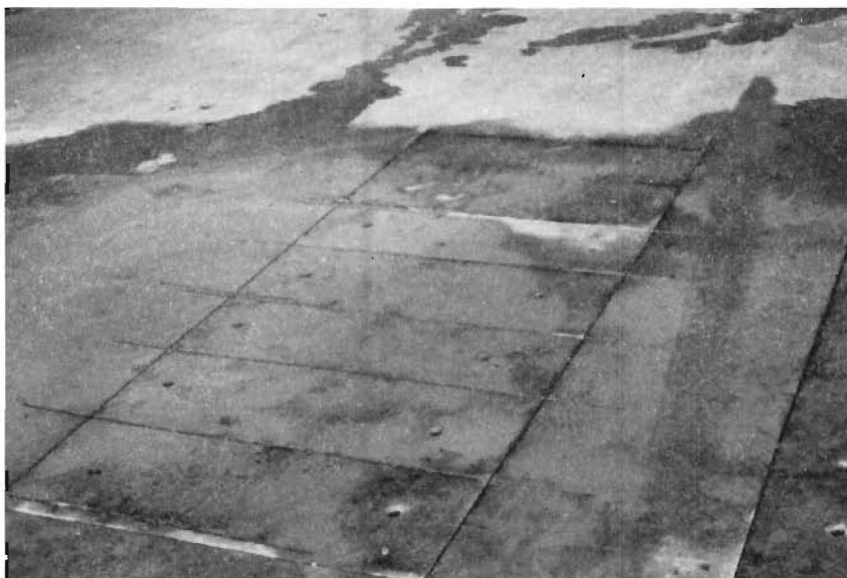
Figure 16: Saw cut slab over Girder 1.

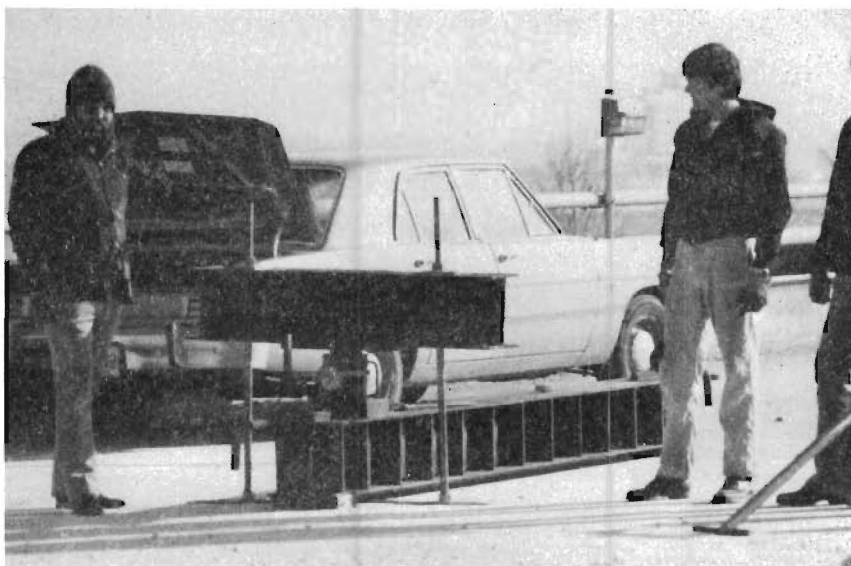
Figure 18: GDOT slab lifting system.

The first method used to remove the cut sections was designed by the Georgia Department of Transportation Research Group. As shown in Figures 18, 19 and 20, the method used a 50-ton hydraulic jack to lift a cross-beam which was bolted to the sections. Unequal forces were developed on either side of the girder which resulted in shear type failure of the sections as shown in Figures 21 and 22. The portion of the sections directly over the stringer remained bonded to

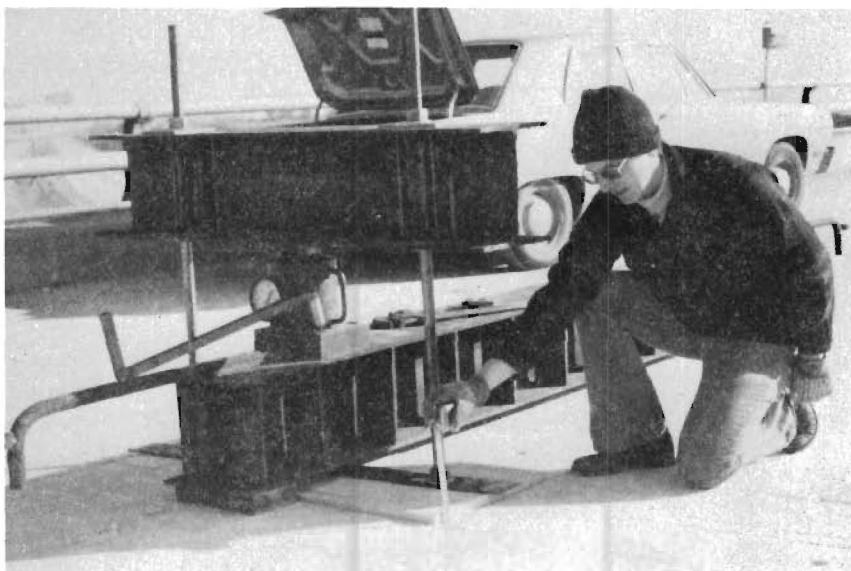
Figure 19: GDOT slab lifting system -  
measuring deflection at failure

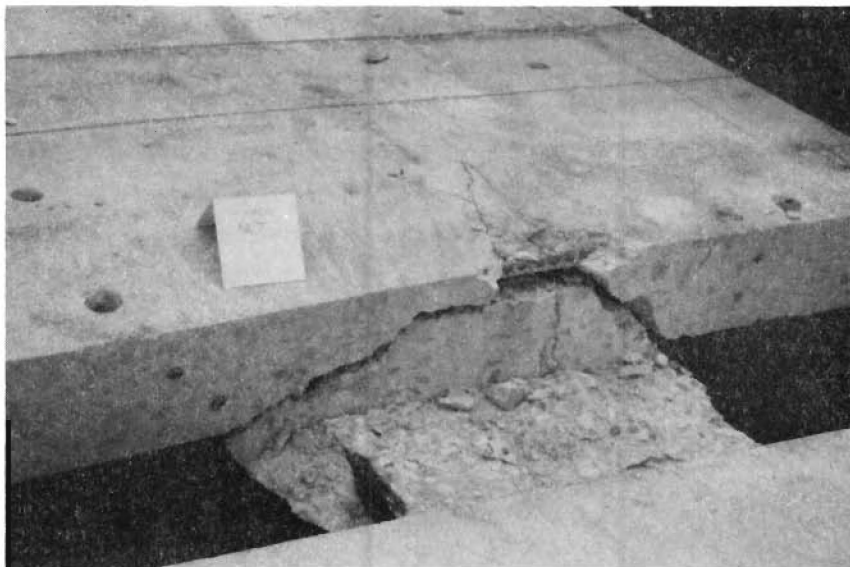
Figure 21: Shear type failure resulting from unbalance of moments. View from on top of deck slab.

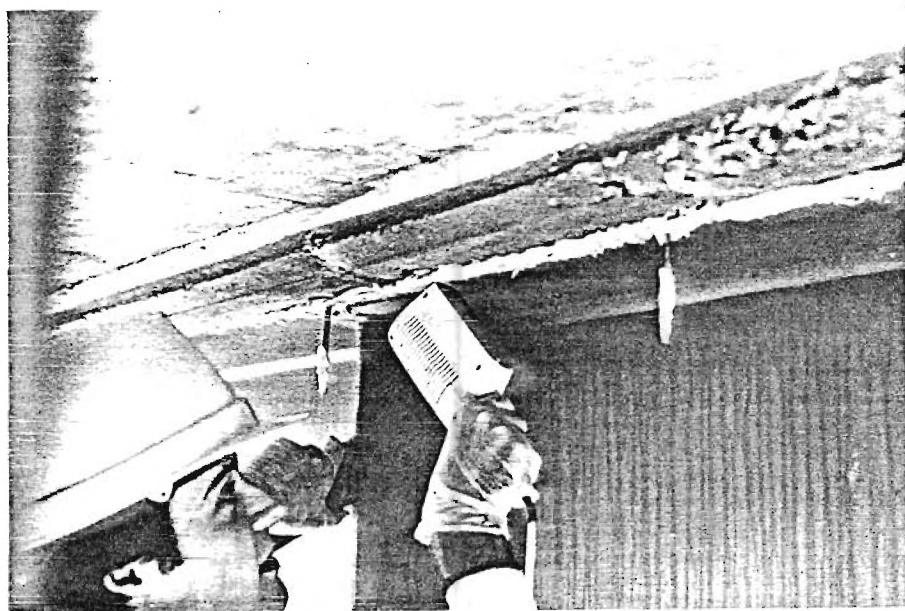
Figure B.6: Drying procedure used on Girders

One problem encountered was the excessive moisture which collected on the steel girders; this condition made adhesion between the steel and sealer very poor. To remedy the situation the steel was dried using a towel and electric 1000 watt dryer (Figure B.6).
